# Injection molding faults in styrene copolymers and their prevention

BASF Plastics  
key to your success

## 4 I. Injection molding faults

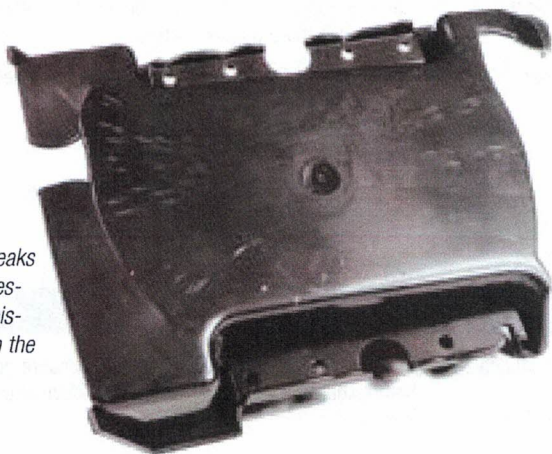
*Fig. 1.1.1: Streaks due to an excessively high moisture content in the granules*

Appearance	Cause	Correction
Usually oblong, silvery surface streaks which are open in the shape of a U counter to the direction of flow. The material pumped out of the cylinder is foamed and shows blisters on the surface.	Moisture content too high; water vapor is produced during melting and this results in the surface of the molding being torn open.	1. Use material adequately predried to a residual moisture content of $< 0.1\%$ . 2. Increase back pressure.

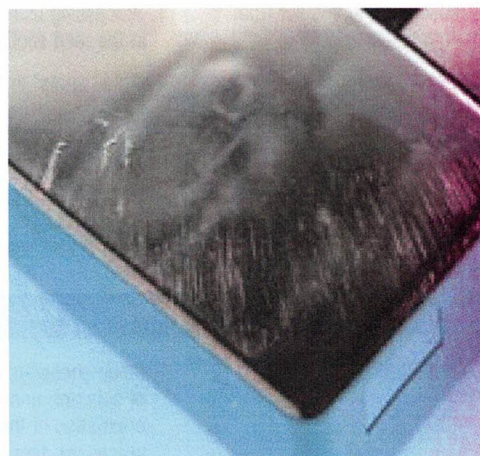
*Fig. 1.2.1: Silvery surface streaks*

Appearance	Cause	Correction
Silvery or dark surface streaks and in exceptional cases black discolorations.	1. Damage to the plastic melt due to excessively high temperatures or overlong residence times resulting from gaseous decomposition products. 2. High shear heating due to small gate cross sections or by sharp changes of direction in the mold.	1. Reduction of the injection speed. 2. Avoidance of undersized gates and sharp changes in direction (shear intensive areas) in the mold. 3. Check the controller of the hot runner system and the barrel heater. 4. Reduction of melt temperature, screw speed (rpm), residence time (if necessary use a smaller plasticizing unit) and back pressure.

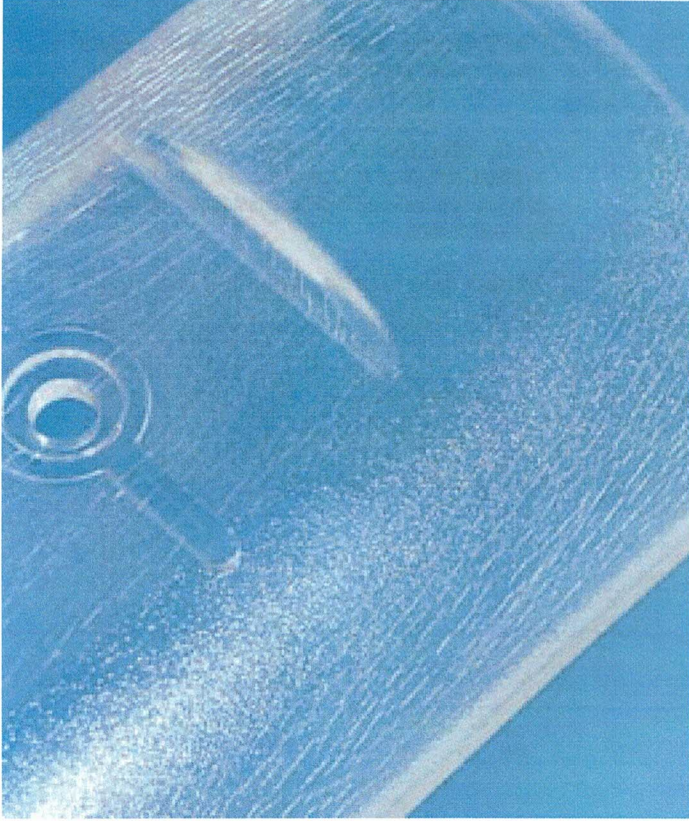
Fig. 8.1: Microcracks produced by overloading and deforming under residual pressure

Appearance	Cause	Correction
Milky to whitish cloudiness (incident light is scattered diffusely).	<p>Due to exceeding the maximum permissible yield point as a result of the following for example.</p> <ol style="list-style-type: none"><li>1. Action of external force, arising for example from forcible demolding of undercuts.</li><li>2. Overstressing the component.</li><li>3. Internal stresses in the part due to inappropriate processing conditions.</li><li>4. Use of mold release sprays which may, for example, cause stress cracking.</li></ol>	<ol style="list-style-type: none"><li>1. Reduce the force acting on the molding from the outside or employ thermoplastics having lower susceptibility to stress whitening e.g. Luran S (ASA) optimize the mold design.</li><li>2. Improvement of the part design.</li><li>3. Increase mold surface and melt temperatures, reduce holding pressure and setting times and adjust injection speed; aim for low-stress processing in line with the requirements of the material; do not demold under residual pressure; select the ejector mechanisms and demolding drafts in such a way that troublefree demolding without relatively great force is ensured; alteration of sprue and gate conditions; modification of part design.</li><li>4. Employ suitable demolding aids.</li></ol>

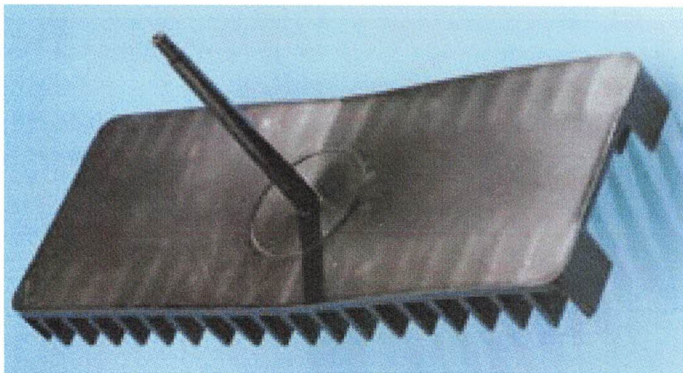
Fig. 10.2: Deformed part as a result of overpacking and shrinkage onto the core of the mold

3. Unsuitable geometry of the moldings, e.g. a highly or disadvantageously ribbed part.	3. Design the molding in line with the nature of the plastic.
	4. Shrinkage on the core during molding/cooling. Ejected part temperature too high. Ejector speed/pressure too high.	4. Cool the core more intensively. Increase cooling time, reduce ejector speed/pressure.

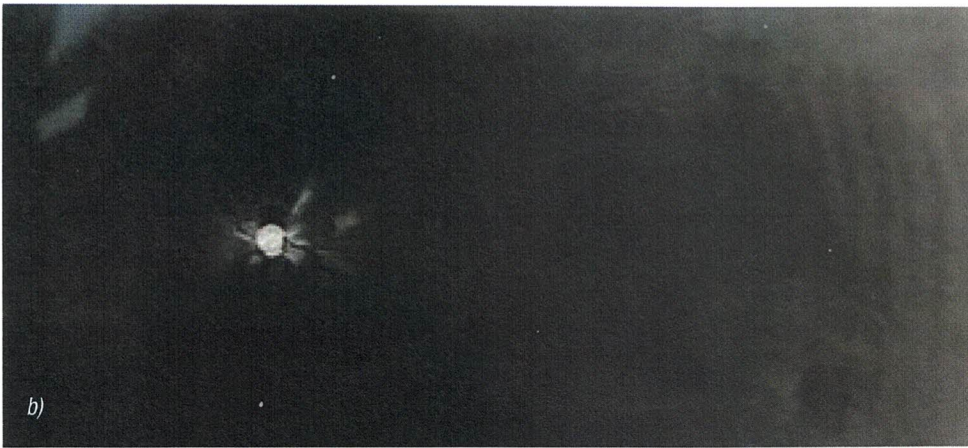
Fig. 11.1:  
a) Tiger stripes as a result of the  
sprue cross section being too  
small  
b) Remedied by enlarging the  
sprue cross section

Appearance	Cause	Correction
Concentric, evenly spaced rings radiating from the sprue which as a result of differences in surface roughness appear alternately light and dark.	<p>Thermoplastic multiphase systems can tend towards pulsating melt flow.</p> <ol style="list-style-type: none"><li>1. Cross section of sprue and gate too small.</li><li>2. High pressure losses in machine and hot runner nozzle.</li><li>3. Wall thicknesses too low.</li><li>4. Inadequate flowability of the molding compound.</li><li>5. Only occasionally are unsuitable processing conditions the cause.</li></ol>	<ol style="list-style-type: none"><li>1. Enlarging the sprue and/or runner cross section.</li><li>2. Reduce pressure losses in the machine and hot runner nozzle.</li><li>3. In the case of thin-walled molding with large surfaces increasing the wall thickness often yields success.</li><li>4. Employ a better flowing material grade.</li><li>5. Optimize the processing parameters (high melt temperature, high mold surface temperature, medium to low injection speed and high holding pressure).</li></ol>

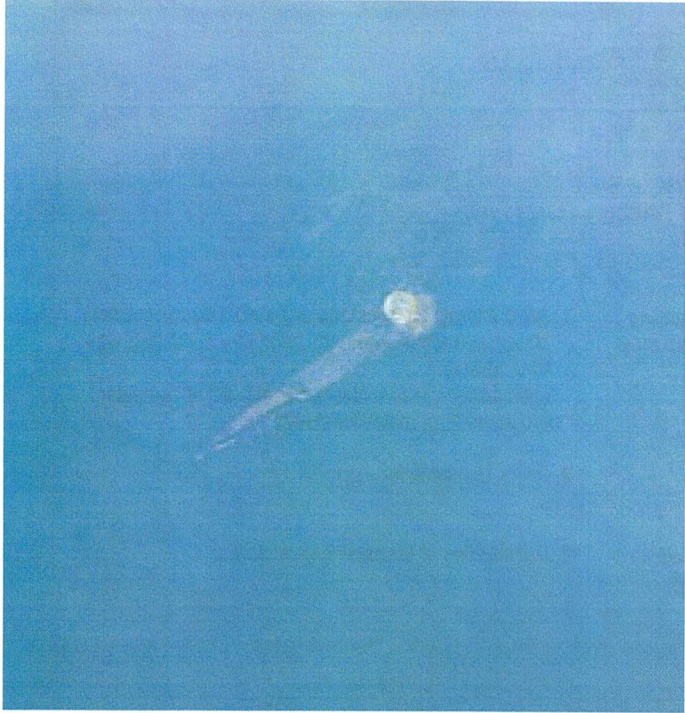
*Fig. 16.1: Cold slug with comet tail*

Appearance	Cause	Correction
<p>The surface mark often has the appearance of a comet tail.</p> <p>Easily visible in the case of thin-walled or transparent parts.</p> <p>In thick-walled parts (not always visible) the cold slug results in an internal flaw or in a reduction of mechanical properties.</p>	<ol style="list-style-type: none"><li>1. When plastic material cools in the gating system or in the nozzle and arrives in the mold on the next shot. Because the already cooled material is not melted again the cold slug can also close up flow channels. As a result of this a division of the melt may arise with consequent surface faults comparable to weld line faults.</li><li>2. An unheated or incorrectly heated machine nozzle.</li><li>3. When, for example, the tip of the tunnel gate breaks off and lands with the next shot in the mold cavity (only arises with brittle materials such as SAN).</li></ol>	<ol style="list-style-type: none"><li>1. and 2. Pay attention to correct and adequate temperature control of the nozzles; make the nozzle cross section large enough; operate with suitably timed and adequately dimensioned screw retraction and reduce the back pressure to such an extent that escape of material from the machine nozzle is prevented.</li><li>3. Provide a cold slug well in the runner which receives the cold slug; as far as possible gating should not be provided by means of a tunnel gate but rather via a hot runner (brittle materials).</li></ol>
